## The Significance of Adverse 3rd-Body Wear Damage in the Failure of Metal-on-Metal Bearings used in resurfacing and Total-Hip Arthroplasty

Elsissy Joseph G, Clarke Ian C\*, John Alun, Smith Evert J and Donaldson Thomas K

Department of Orthopaedics, Loma Linda University Medical Center (LLUMC), United States

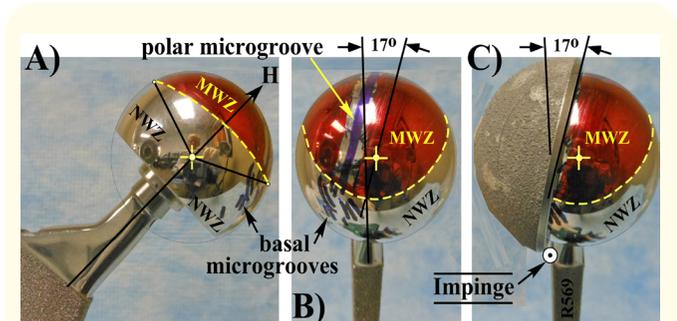
**Figure 2:** Superior main-wear zone (MWZ) stained red to differentiate from inferior non-wear (NWZ) zone. Polar and basal microgrooves stained blue and black, respectively.

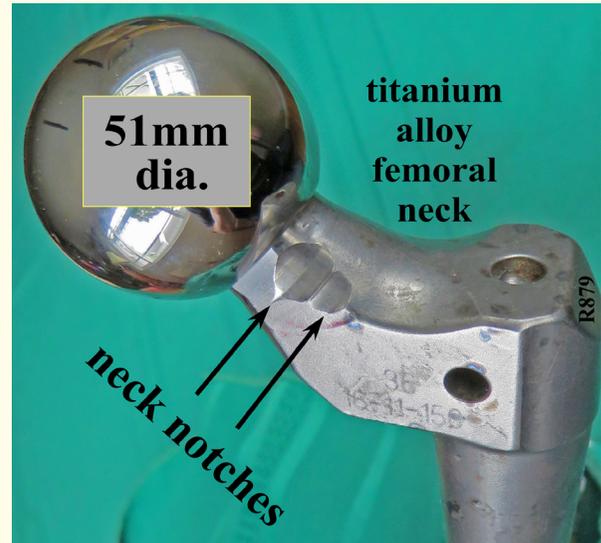
**Figure 3:** Twin notches on retrieved THA femoral-neck (titanium-alloy), 51 mm SRM case presented by permission of J. Recon. Review [Donaldson, 2015].

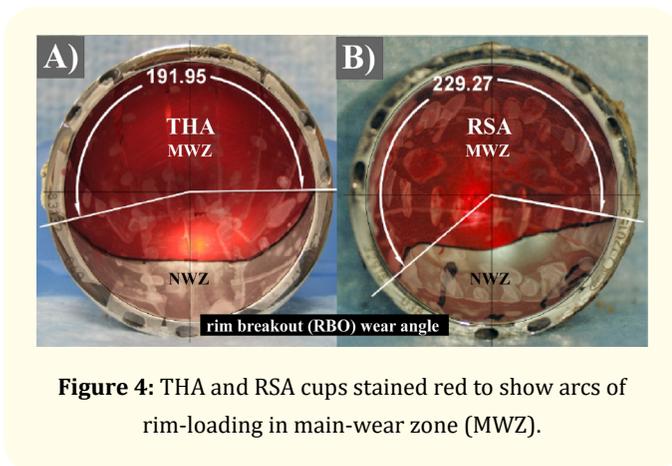
**Figure 4:** THA and RSA cups stained red to show arcs of rim-loading in main-wear zone (MWZ).

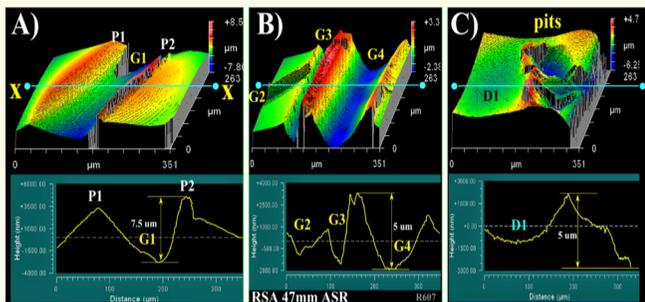
our WLI analysis, these measured 150 - 160  $\mu\text{m}$  wide with valley depths 5 - 10  $\mu\text{m}$  and were frequently found in proximity of microgrooves (Figure 6). These images also revealed the plowing/abrasive behavior of the presumed large metal fragments. The intersection of microgrooves demonstrated considerable plastic deformation of the rims and a similar plastic-deformation flowing onto the valley floors, the latter resembling the debris fields of avalanches (Figure 7).

**Figure 6:** WLI images of 47 mm RSA femoral head showing pitting and microgrooves approximately 160  $\mu\text{m}$  wide with valley depths 5 - 7  $\mu\text{m}$ , A) microgroove with one side smooth and one rim sharply elevated, B) intersecting microgrooves, and C) multiple pits.

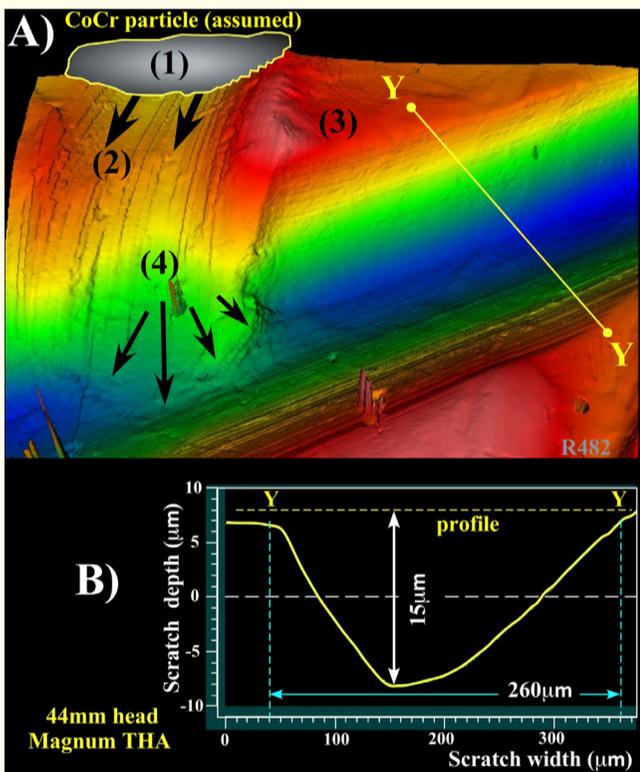
**Figure 7:** WLI imaging of intersecting microgrooves (note magnification Y-axis =  $\times 10$  x-axis),

1. Cartoon of hypothetical metal fragment
2. Longitudinal striations in microgroove-1
3. Plastically-deformed shoulder above microgroove #1
4. Avalanche appearance of cold flow confirming plowing direction of fragment penetrating microgroove-2
5. Y-Y section for microgroove-2 profile in (B)

Y-Y cross-section profile for microgroove #2 with peak width 260  $\mu\text{m}$  and valley depth 15  $\mu\text{m}$ .

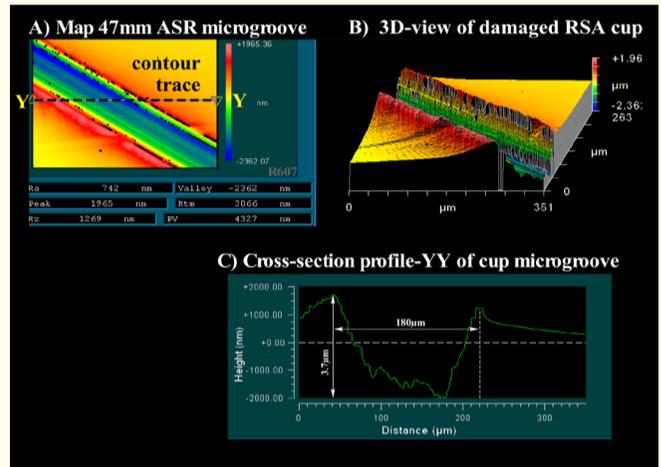
**Figure 8:** WLI imaging of microgrooves in RSA cup (note magnification Y-axis =  $\times 10$  x-axis).

A. Cup surface with large scratch

C. Microgroove profile revealing 180  $\mu\text{m}$  between peaks, valley depth of 3.7  $\mu\text{m}$ .

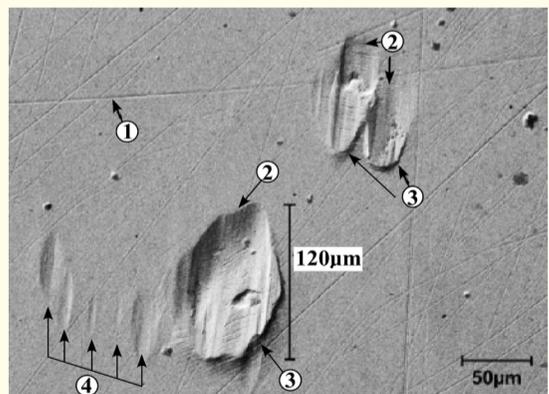
**Figure 9:** SEM images of large pits in basal zone of head.

1. Typical background scratches in CoCr
2. Smooth terminus in defects
3. Elevated pit rims
4. Multiple shallow impact sites

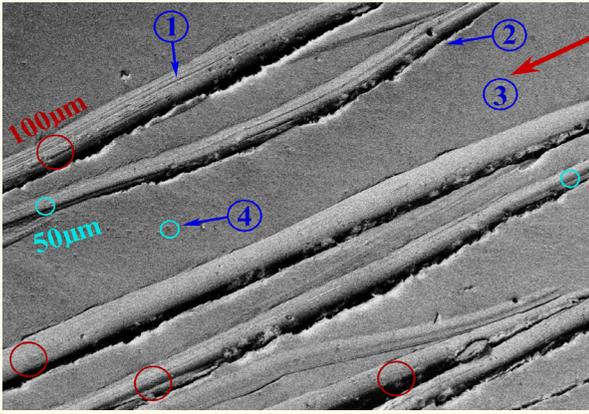
**Figure 10:** Array of basal microgrooves typically 100 µm width in RSA femoral head (43 mm ASR).
