Re-treatment of Maxillary Premolar with Calcified Canals and Inadequate Obturation

This case report aims to present a Case of Symptomatic Apical Periodontitis (SAP) with chronic abscess associated with a previous root canal treatment with inadequate obturation in a maxillary premolar.

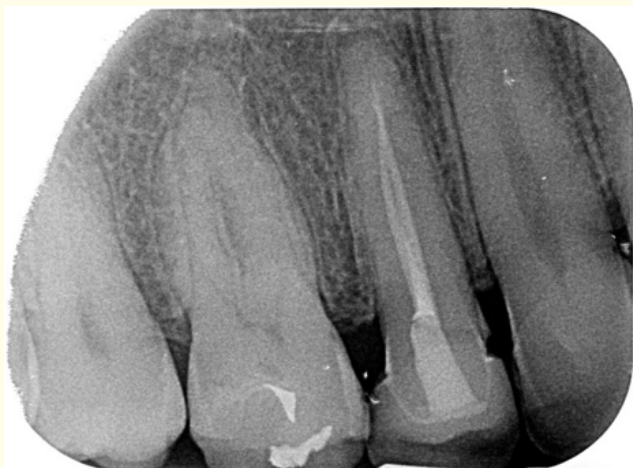
Previous root canal treatment in 15 with short obturation is visible on periapical radiograph. The root is associated with periapical radiolucency. The apical part of the canals suspected to be calcified (which are Unobtured) (Figure 1).

Figure 1: Periapical radiograph inadequate root canal treatment in 15. Periapical radiolucency associated with the root of 15 can also be seen.

In the present case, ineffective cleaning and shaping of the apical part of the root canal lead to short obturation with inadequate apical seal. This gave a chance to the microorganisms to proliferate and start the immune-pathological mechanisms resulting in apical periodontitis.

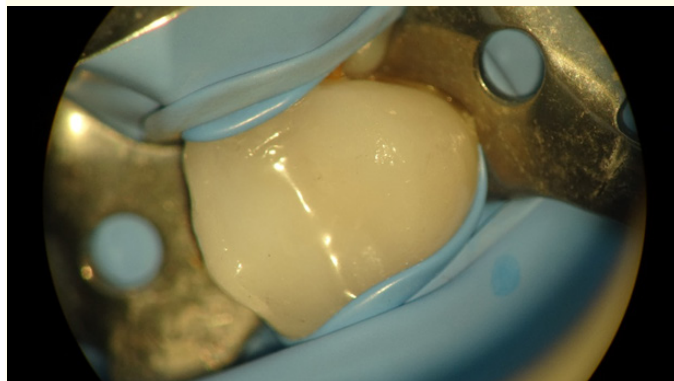
Figure 2: Tooth 15 under isolation with all ceramic crown before starting with the retreatment procedure.

1. Buccal infiltration anesthesia was administered, the tooth was isolated with rubber dam (Figure 2).
2. Endodontic access was gained through the crown and previous gutta perchas were found (Figure 3).
3. Gutta perchas were removed with the help of Endoshaper file from FKG used at 2500rpm (Figure 4) (Video 1). Intracanal medicament was placed and patient recalled for second appointment (Figure 5).

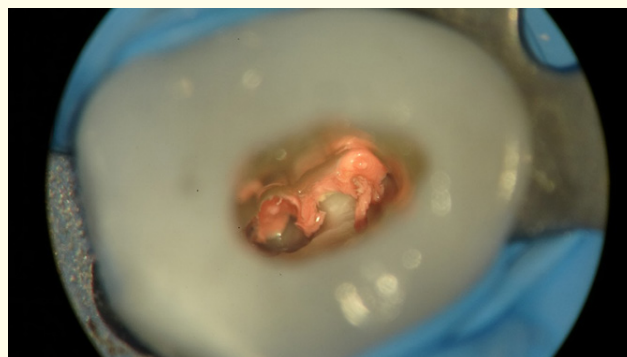
Figure 3: Endodontic access cavity made through the ceramic crown. Older gutta perchas located.

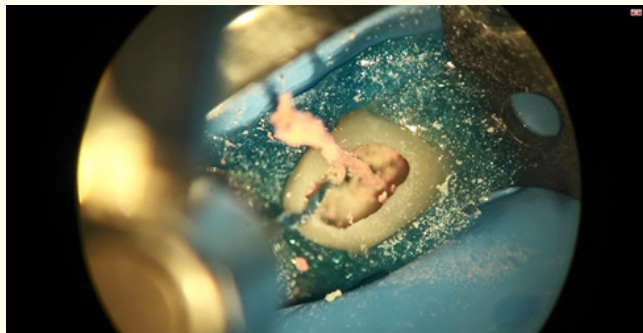
Figure 4: Removal of gutta perchas with Endoshaper files from FKG.

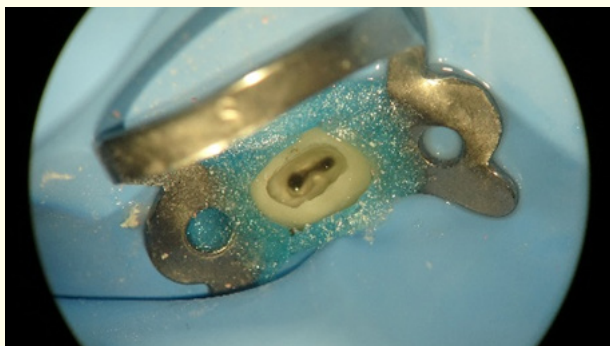
Figure 5: Previous gutta percha removed from the root canals.

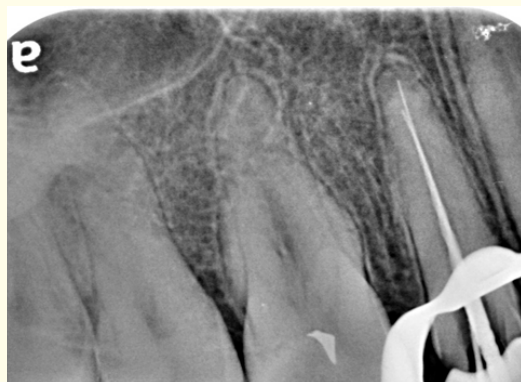
Figure 6: Periapical radiograph verifying the working length.

1. The all-ceramic crown came out during clamp placement. Sodium hypochlorite was used as an endodontic irrigant. 08K and 10K endodontic files were pre curved and used to open the calcified canals. C+ files were also used in order to open up the apically calcified part of the root canals. These files were used with passive motion in presence of the irrigants. After negotiation of the apical part, working length was determined with Electronic apex locator and verified with a periapical radiograph (Figure 6).

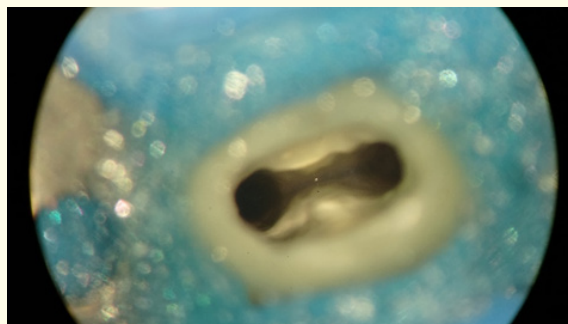
Figure 7: Canals prepared up-to 25/04.

2. Both the canals were finally prepared up to 25/04 (Figure 7).
3. Master cone fit was verified clinically with tug back. Also, periapical radiograph was taken to verify their fit at the correct working length (Figure 8).
4. Obturation was done using GP and AH Plus as a root canal sealer. Warm vertical condensation technique was used for obturation (Figure 9).
5. Final obturation was verified with an immediate postoperative radiograph (Figure 10).
6. 6-month recall of the case showed adequate healing and patient remained asymptomatic (Figure 11).

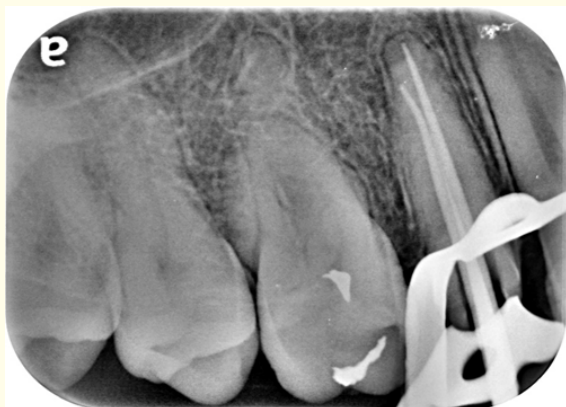
Figure 8: Periapical radiograph verifying the master cones for obturation.

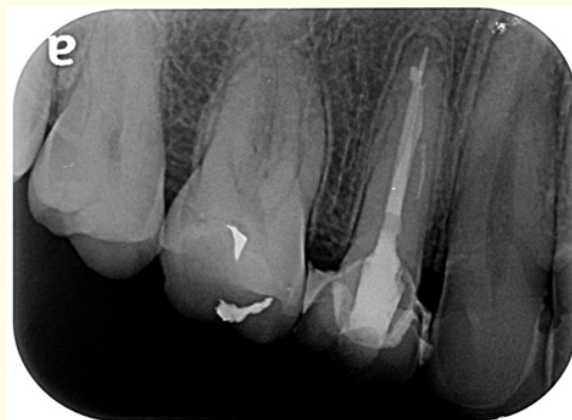
Figure 11: 6-month recall radiograph showing intact crown, obturation and ongoing healing of the periapical area.

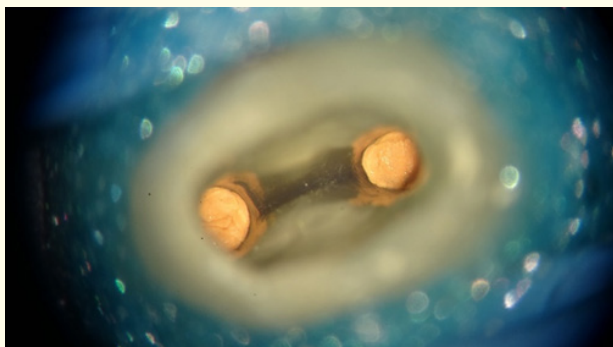
Figure 9: Obturation of the root canal system.

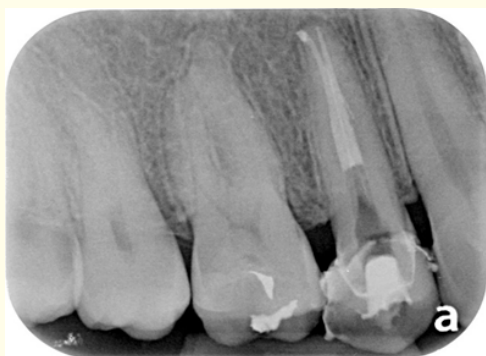
Figure 10: Immediate postoperative radiograph to verify the obturation.
