## The Significance of Adverse 3rd-Body Wear Damage in the Failure of Metal-on-Metal Bearings used in resurfacing and Total-Hip Arthroplasty

Elsissy Joseph G, Clarke Ian C\*, John Alun, Smith Evert J and Donaldson Thomas K

Department of Orthopaedics, Loma Linda University Medical Center (LLUMC), United States

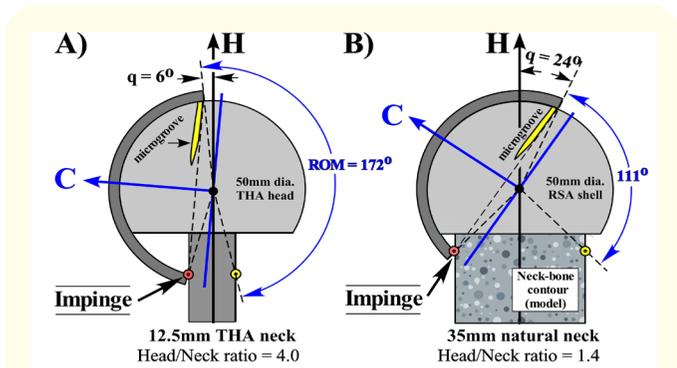
**Figure 1:** 50 mm MOM impingement models with 160°-profile cups:

(A) THA with 12.5 mm diameter neck has head: neck ratio 4.0 and ROM = 172°.

(B) RSA with 35 mm natural-neck has head: neck ratio 1.4 and ROM = 111°.

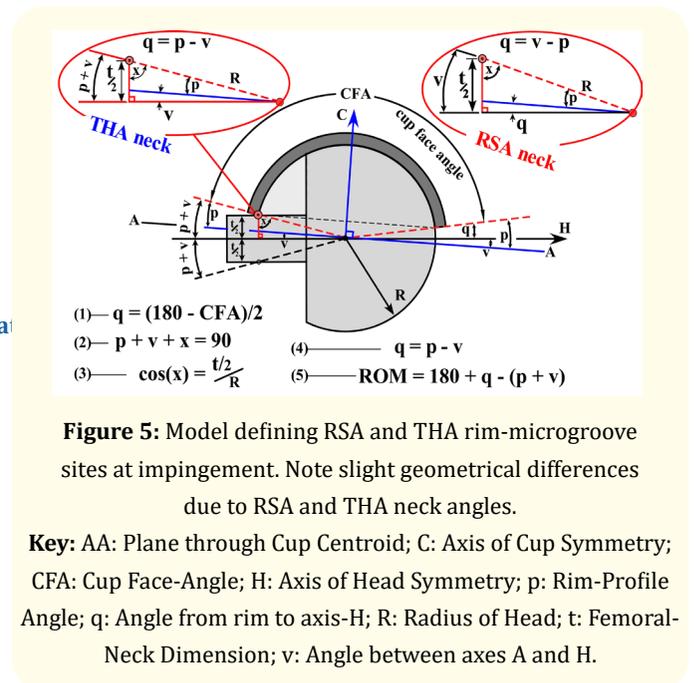
**Figure 5:** Model defining RSA and THA rim-microgroove sites at impingement. Note slight geometrical differences due to RSA and THA neck angles.

There are many limitations in hip retrieval studies. At the beginning of study, our opinion was that potential for reduced ROM in RSA cases [24] would result in polar microgrooves with larger q-angles than RSA cases (Figure 1). The impingement models were useful for ROM and angle-q data (Figure 5) but did not differentiate between THA and RSA microgroove sites. However, the evidence that RSA femoral components featured similar polar microgroove formations as THA supported hypothesis 3. In addition, due to the small sample size it would be difficult to find differences in RSA and THA wear patterns. Even significant differences found with respect to hemi-area ratios and arcs of rim-loading in RSA cups could possibly be due to combinations of (i) surgical positioning, (ii) hip subluxation, or (iii) likelihood that RSA patients were more active than their THA counterparts. Thus, hypothesis 2 remains unproven, that RSA cups would have larger wear areas and greater arcs of rim-loading than THA.

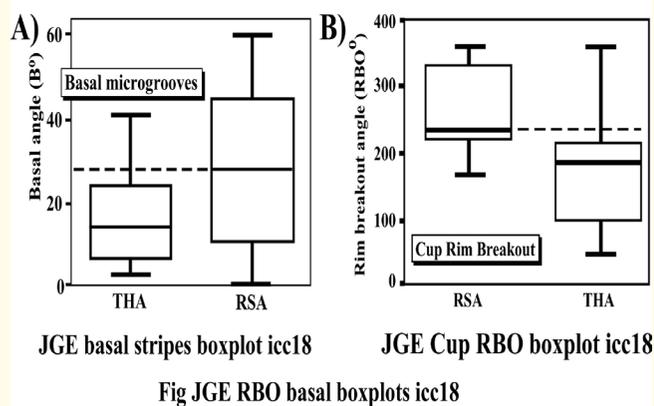
**Figure 11:** Boxplot analyses with A) arcs of rim wear (RBO), and B) basal microgroove angles.
