Partial Porcelain Veneer Restoring Maxillary Incisor with Class II Cavity

Department of Fixed Prosthodontics, Research Laboratory of Occlusodontics and Ceramic Prostheses, Faculty of Dental Medicine, University of Monastir, Monastir, Tunisia

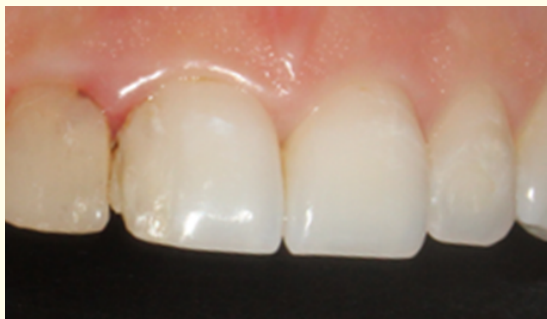
Clinical examination showed good hygiene, gummy and large smile, the 12 and the 11 present a direct restoration by composite resin, which was discolored with the inflammation of the papilla between the two teeth.

Figure 2: The initial situation.

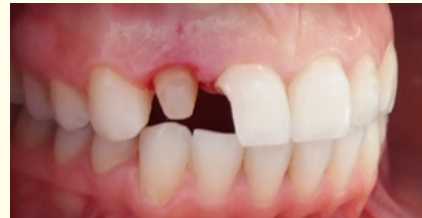
The defective composite on the 12 was removed and the tooth was prepared. Thereafter, a glass fiber post was placed. The esthetic core was built up with composite resin and bonded with self-adhesive resin luting cement (Figures 4,5).

Figure 5: Fiber post reconstruction.

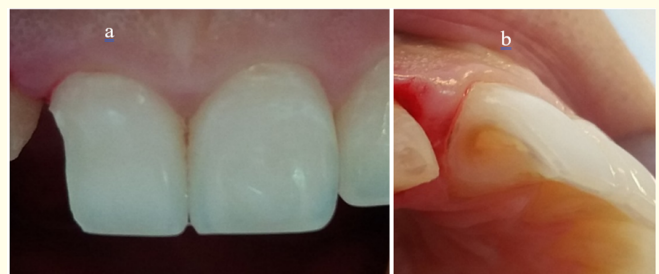
The preparation of the central incisor was the least invasive with maximal preservation of enamel tissue (Figure 6). In addition, like all the partial ceramic restoration, there are some guidelines of preparation were respected:

- All the angles had to be rounded.
- The divergence of the internal walls should not be too limited ($\geq 10^\circ$).
- The cavo-superficial boundaries shall be sharp, without bevel.
- Occlusal areas should not be located at the tooth restoration interface.

Figure 6: Preparation of the 11 a: buccal view; b: occlusal view.

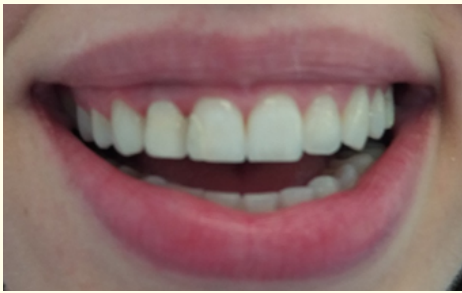
Temporary prosthesis were cemented in order to improve the esthetic appearance of the patient's smile (Figure 7).

Figure 7: Temporary prosthesis.

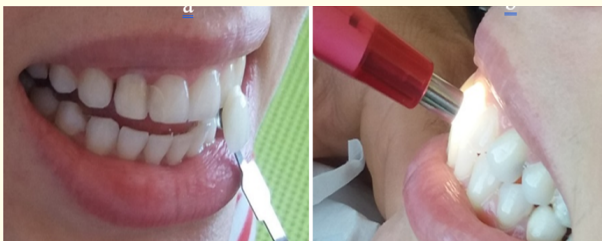
After double gingival cord retractions, an impression was made using light and heavy silicon C (Figure 8). The shade selection was done using both the classic and the digital shade guide (Figure 9).

Figure 9: Color selection a: the use of a classic shade guide; b: the use of a digital shade guide.

These problems can be overcome by the choice of the corresponding preliminary color matching using a digital shade guide, and taking advantage of optical properties of adhesive materials.

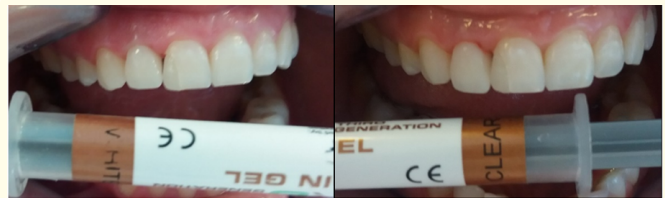
With the translucent partial veneer, it is important to control the color of the restorations with a try-in paste; the white bonding resin was selected to match the restoration and the tooth, to ensure an invisible margin (Figures 12,13).

Figure 12: Control the colour of the restorations with a try-in paste.

Before bonding procedure, the partial restoration should be checked intraorally with a try-in pastes, which were used as indicators of the final shade and as a guide to choose an appropriate color of the bonding composites [17].

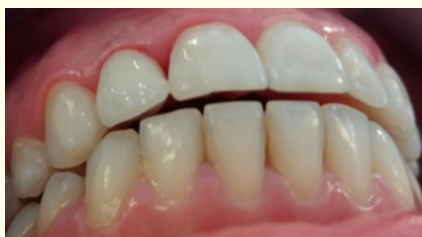
In our case, the patient presents an anterior open bite with absence of incisive contact. Thus, the interface tooth-restoration is at distance from the occlusion, which may improve the prognosis of the partial veneer (Figure 17).

Figure 17: Anterior open bite.

Moreover, a high priority should be given to the examination of the patient's occlusion, as in the present case, the anterior open bite was favorable for the indication of this type of restoration. Therefore, it is important to select the biomechanical principles and the appropriate occlusal context that can optimize the final outcome.

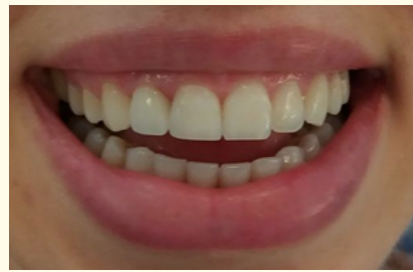
The patient was satisfied with the result and has not reported any problem, any color changes during one-year follow-up (Figure 18).

Figure 18: Final esthetic smile.
